# **THE PRESERVATION SOCIETY OF NEWPORT COUNTY**

## **WHITE PAPER**

### **Implementation of a Ground-Source Geothermal System at The Breakers for Dehumidification to Protect Collections**

By Christopher Daly, Director of Properties & Patricia Miller, Chief Conservator

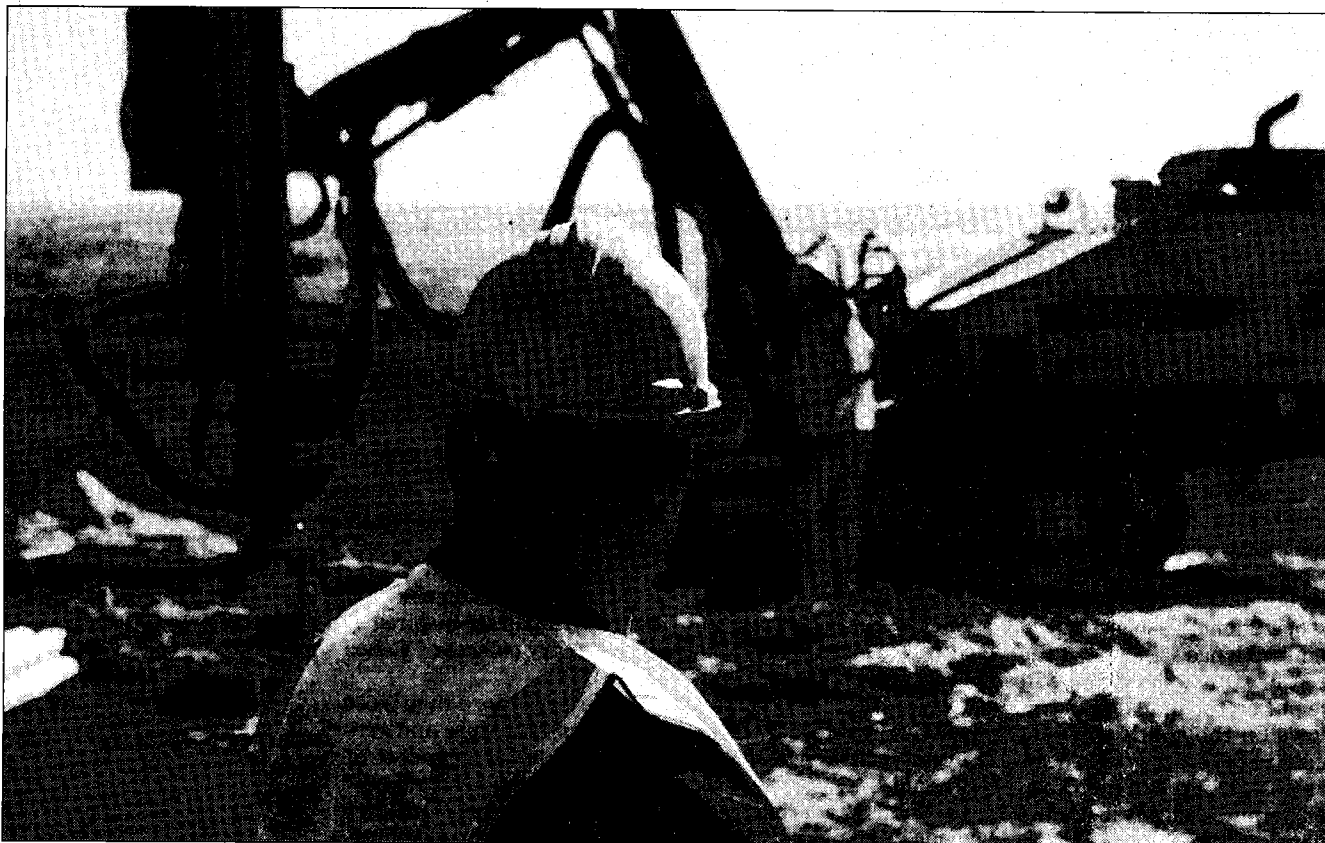
Brian Lawrence supervises the progress of a drill at The Breakers in Newport.

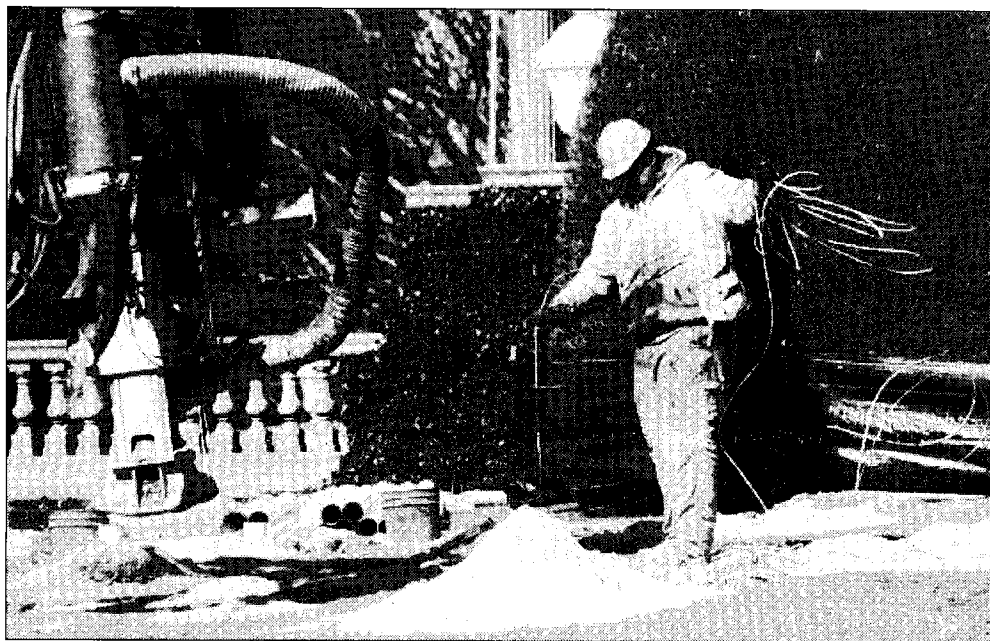
Curt Genga, above, properties director for the Preservation Society of Newport County, explains the work being done at The Breakers. At top, Wyatt Wunderlich finishes up with one of the holes that was drilled recently as part of the new geothermal system.

Two copper tubes will be inserted down to the depths of each of the 75 holes and then will lead underground under the back patio of the mansion to connect to 16 heat pumps, which can operate in reverse to cool, and to condensers that will keep the humidity of the air inside the mansion at a steady 55 percent all year round.

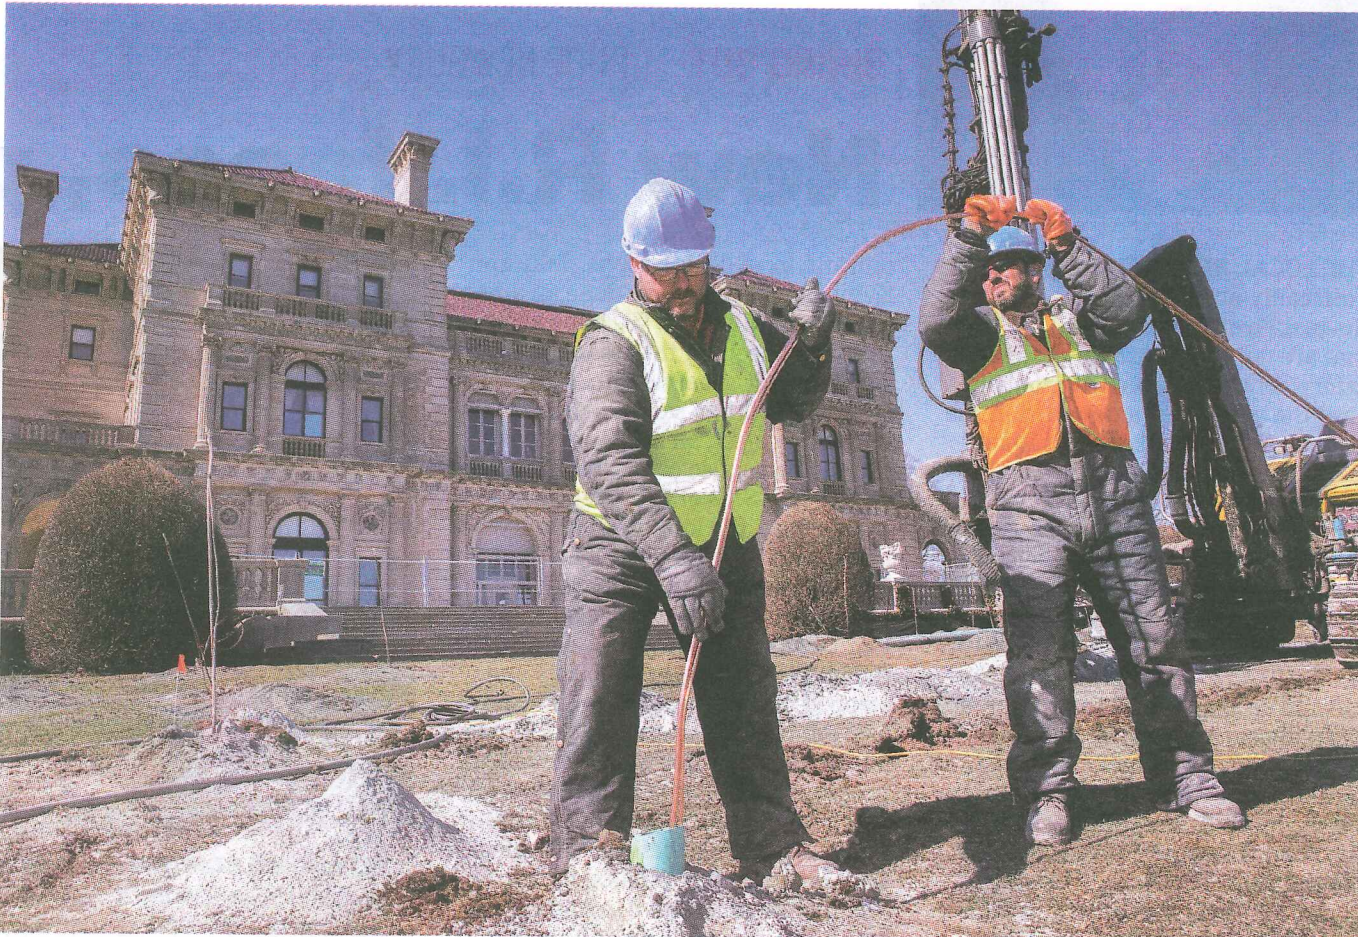
**IN THE LOOP:** Lawrence Air Systems Inc. co-owner Brian Lawrence, left, and employee Jim Fulton install a ground loop for a geothermal system at The Breakers in Newport.
